FBE Found Effective After 30 Years Of Service

By **Toby Fore, Kinder Morgan Inc.**, and **Kuruvila Varughese, DuPont Powder Coatings**

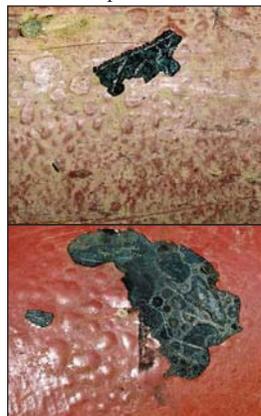
The length of pipe excavated and exposed at Site A was approximately 35 feet. The length of pipe excavated and exposed at Site B was approximately 50 feet. Visual inspection over the entire length of the exposed areas revealed only a single isolated colony of blisters on each exposed pipeline. The amount of blistering at Site A was approximately 0.13% of total surface area and approximately 0.16% of total surface area for Site B. The total surface area of each blister was 0.135 square feet at Site A and 0.17 square feet at Site B.

Photos 1 & 2: Magnetite coating beneath coating blisters. Site A (top) Site B (bottom)

Both high pH and the presence of the magnetite film appear to support past work which suggested that FBE does not shield cathodic protection current^{4,5}. Similar behavior was observed on FBE-coated pipelines in the Middle East Subkha Area⁶.
